# ESSEX COPPER PROCESSING PLANT

BEAVER COUNTY, UTAH  
EPA ID 988066064

# ANALYTICAL RESULTS REPORT

Utah Department of Environmental Quality  
Division of Environmental Response and Remediation  
Prepared By: Jason L. Knowlton

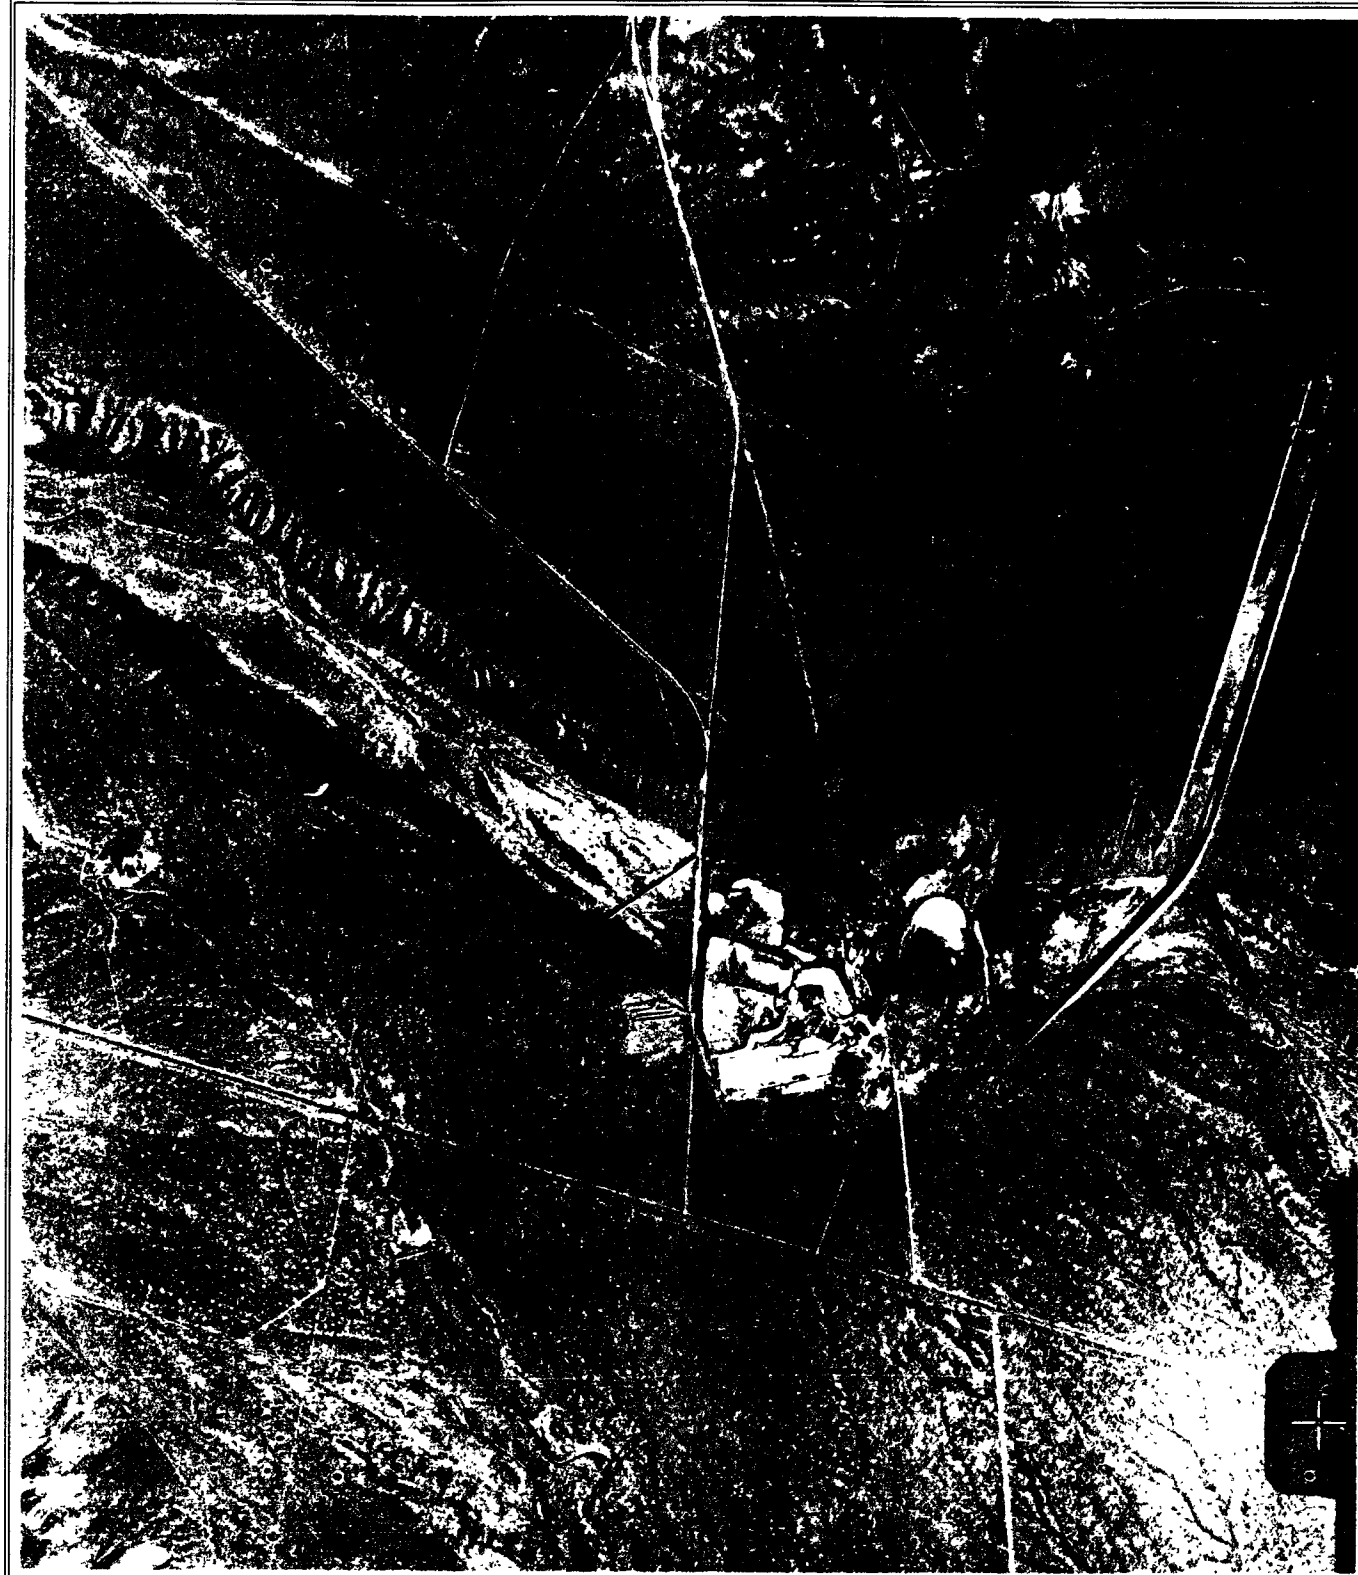
Seven soil samples were collected from the waste pile at locations shown on Figure 7. The samples were collected with a stainless steel spoon from the soil surface, and these were all collected as "grab samples," except sample EC-SO-03. Sample EC-SO-03 was composited from

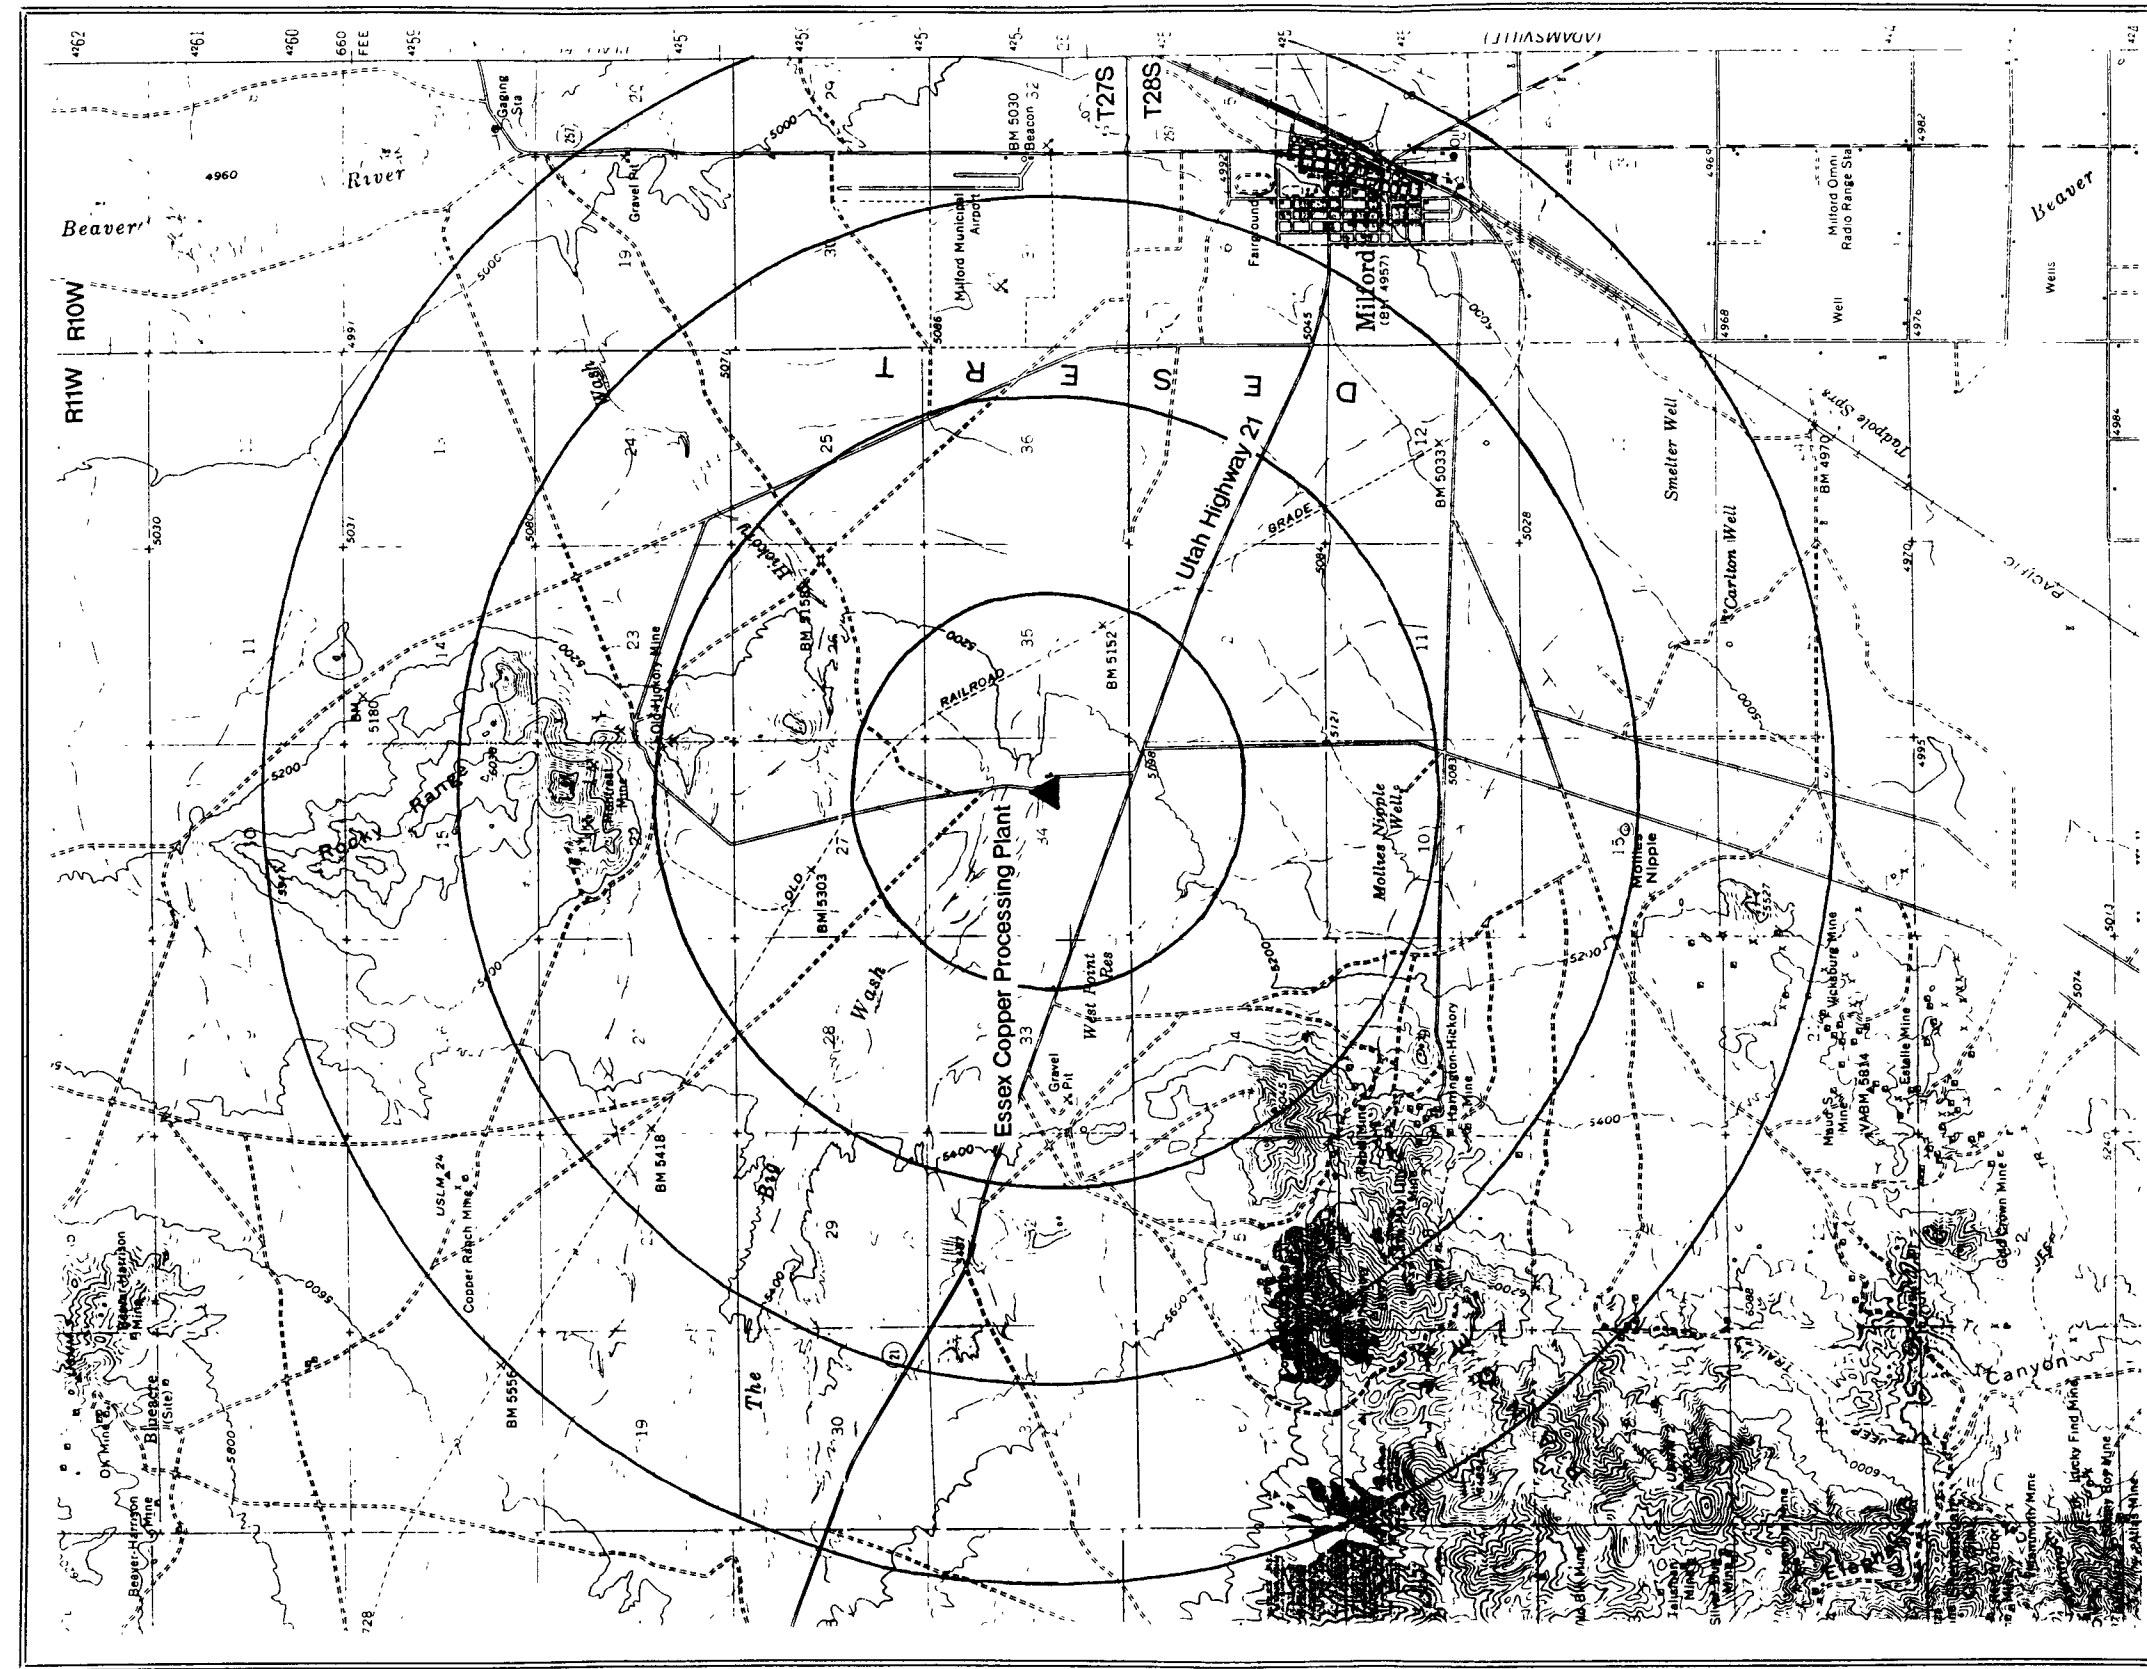
Within a 4 mile radius from the site, there are 42 wells, most of which are downgradient from the site; 7 of these are for municipal supply; 12 are used for domestic purposes; 24 are for irrigation, and 17 are for stock water<sup>24</sup>. Appendix K contains a map showing well locations and utilization, and printouts from the Utah Division of Water Rights and the Utah Division of Drinking Water. Note that some of these wells have multiple uses. Figure 8 shows a 4 mile radius from the site.

Large circles indicate 1, 2, 3 and 4 mile radii from site
